Manhole Inspection Summary

Manhole # **S13GG1022MH**

Insp Date: **6/13/07 2:36 PM**

Location Address: **2644 PIMLICO RD**

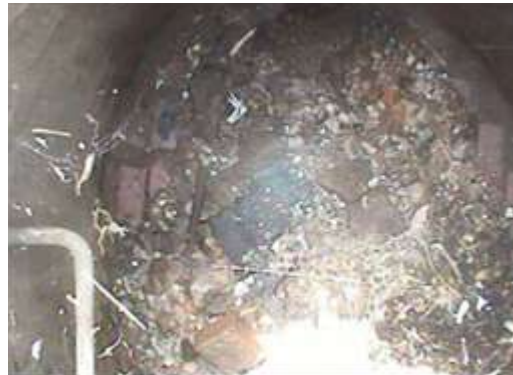
Top View

DEBRIS ON CHANNEL

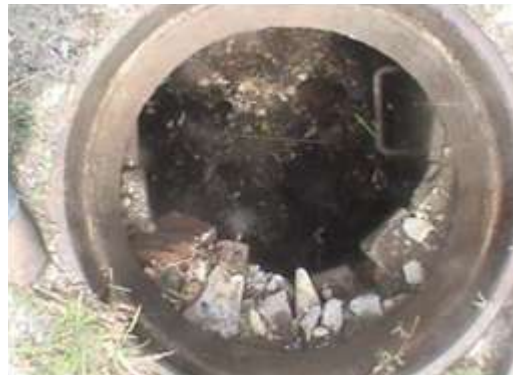
Defect 1

Condition: ☐ Sound ☐ Cracked ☐ Root Intrusion ☒ **Loose Brick** ☒ **Deteriorated**

DETERIORATED AND LOOSE BRICKS OF CHIMNEY

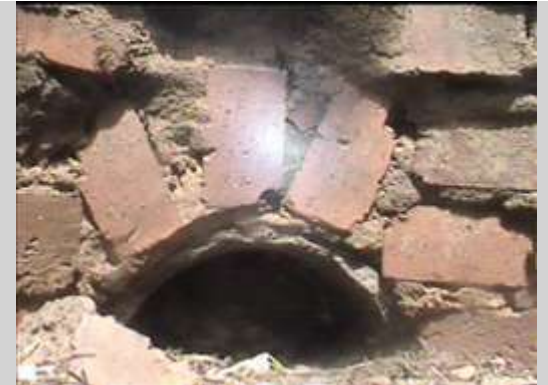
12 O'Clock Outflow

Deposits: ☐ None ☐ Mud ☐ Sludge ☒ **Debris** ☐ Grease

Silt Depth: **5** (in.) Deposits Extent: **Heavy**
